MUNICIPAL SEPARATE STORM SEWER SYSTEM (MS4)

WYOMISSING CREEK WATERSHED TMDL

THE WYOMISSING CREEK WATERSHED COALITION

JULY 25, 2017

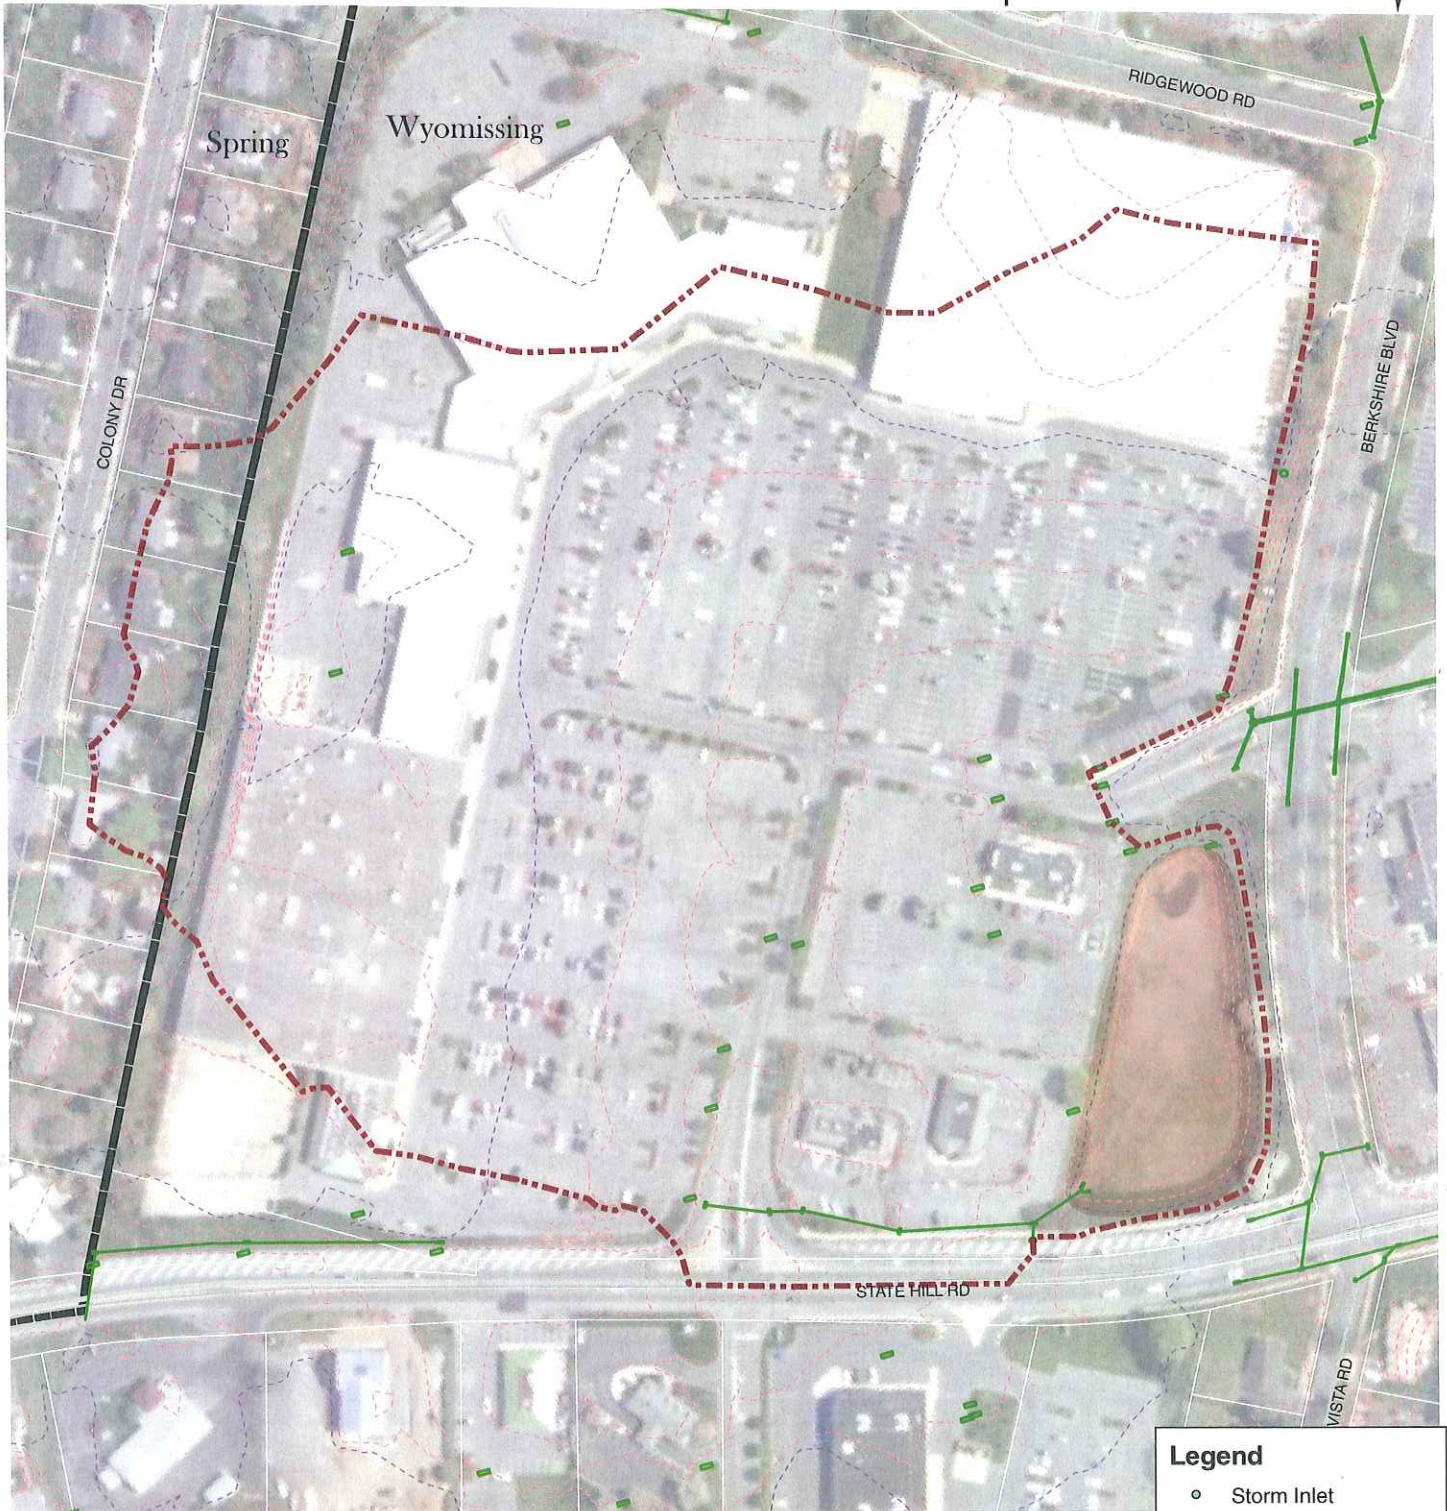
DRAFTED BY: J. MILLER	SCALE: 1" = 500'
CHECKED BY: N. JOHNSON	DATE: 6/28/2017
PROJECTION: NAD83 STATE PLANE	DRAWING NUMBER: 3017-003-A-104

# Wyomissing Creek Watershed Berkshire Boulevard Basin BMP Map

**WYOMISSING CREEK WATERSHED  
BERKSHIRE BOULEVARD BASIN BMP MAP**

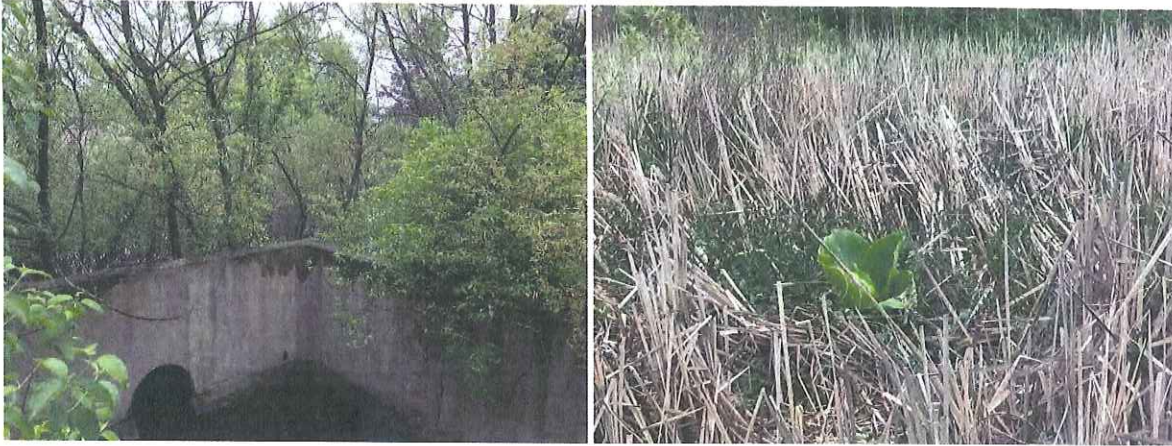
## Kuser Dam (EC\_01)

The Kuser Dam appears to be a pass-through for Kline Creek (we believe), a high-quality stream among Pennsylvania's designated-use waterways. The low-elevation outlet at the dam structure likely got partially clogged by detritus some time ago, and additional plant matter has since accumulated behind it. This has fostered the development of a full and healthy wooded wetland environment. A wide variety of wetland taxa were observed, both flora and fauna. The depth at the outlet structure was measured at 57 inches. The effective depth used for volume calculations was one third of this, fitting the volume formula for a cone, or the average of the area-integral of parabolic cross sections of the basin. We feel this was relatively conservative.

There appears to be no threat of obstruction or damage to the existing overflow structure, which still has 27 inches of available elevation before being reached. There was observed "baseflow" through the low-elevation orifice at this structure, so water is still getting through, though the rate may or may not be sufficient to support the stream reach beneath it. However, the outlet of the Kuser Dam appears to lead directly into what is described within this report as PennDOT Lancaster 6 (RE\_04), which subsequently flows into PennDOT Lancaster 5 (RE\_03). From there it appears to cross under Lancaster Pike and to Wyomissing Creek, past the Summit Heights outfall plunge pool (NR\_03). Fish and animal movement is likely not supported through this set of culverts and structures, but the baseflow rate from Kline Creek through Kuser Dam may require some modification to the outlet structure. It is likely at this point that the established wetland mass behind Kuser Dam precludes the normal "maintenance" procedures of removal of accumulated sediment, for example.

To be clear in our recommendations, we recommend not doing anything at Kuser except the bare minimum necessary to ensure there are no health or safety risks associated with the current condition. This appears to be a healthy, established wooded wetland which is providing significant ecosystem and water quality benefits. If possible, it should be left alone.

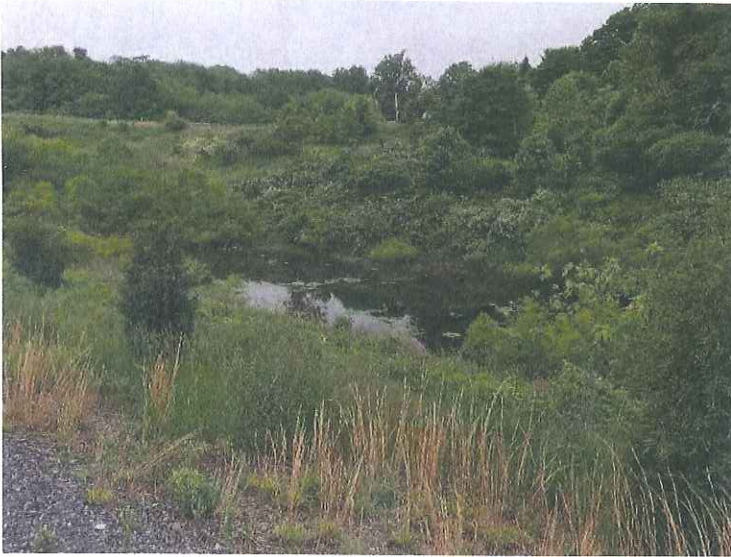
## PennDOT Lancaster 3 (RE\_01)

This basin likely has debris obstruction of the culvert outlet, causing a standing water condition. The result is water quality treatment provided by wooded wetland vegetation and a small wet pond for sediment settling. This unintentional wetland can be enhanced by adding an outlet structure designed to retain additional water, before a designed overflow allows water through the culvert. This would expand the wetland and increase the size of the wet pond.

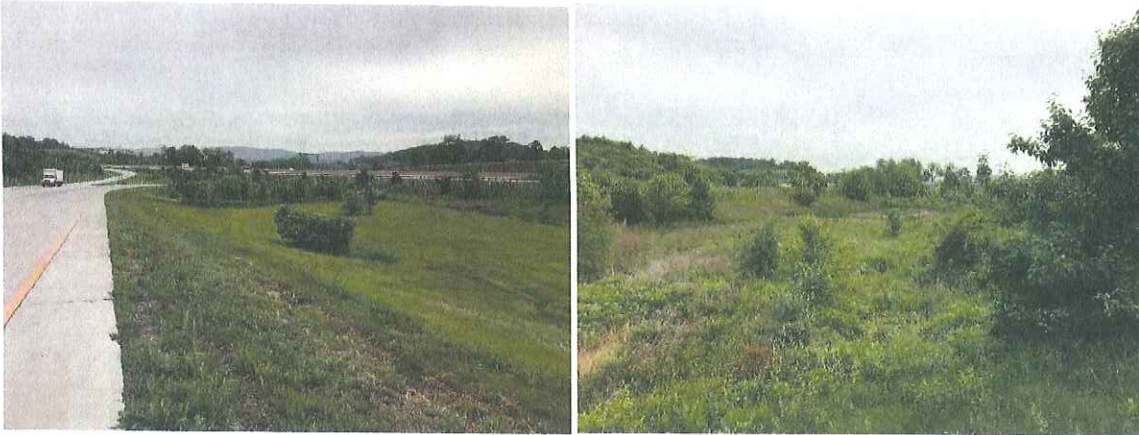
## PennDOT Lancaster 4 (RE\_02)

The low benefit associated with retrofit work here, no matter how cheap it is relative to other retrofit options, makes this a very low benefit:cost project. The mobilization cost associated with even small projects likely makes this impractical.

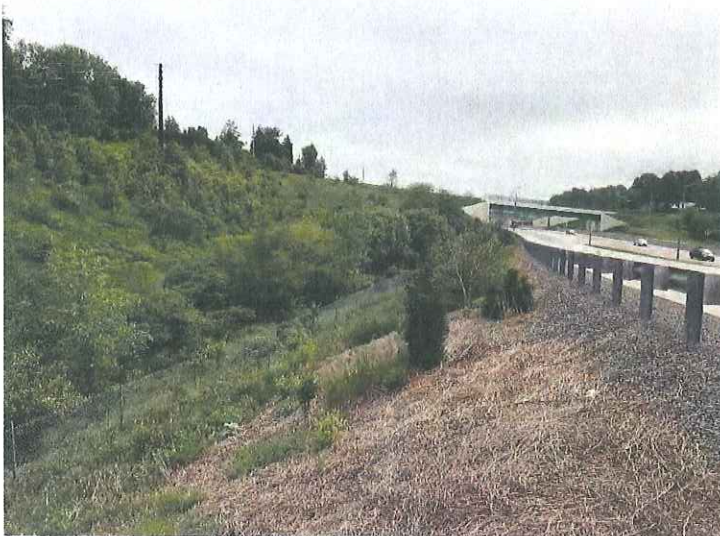
## PennDOT Lancaster 5 (RE\_03)

This detention basin appears to be forming into a wooded wetland and has significant potential for greater water quality treatment. Adding an outlet structure before the culvert will retain additional water, allowing for infiltration, evapotranspiration, and eventually development of more wetland taxa. The basin receives flow from PennDOT Lancaster 6 (RE\_04), which in turn receives flow from the Kuser Dam (EC\_01), believed to lie along Kline Creek, a HQ-CWF tributary of Wyomissing Creek.

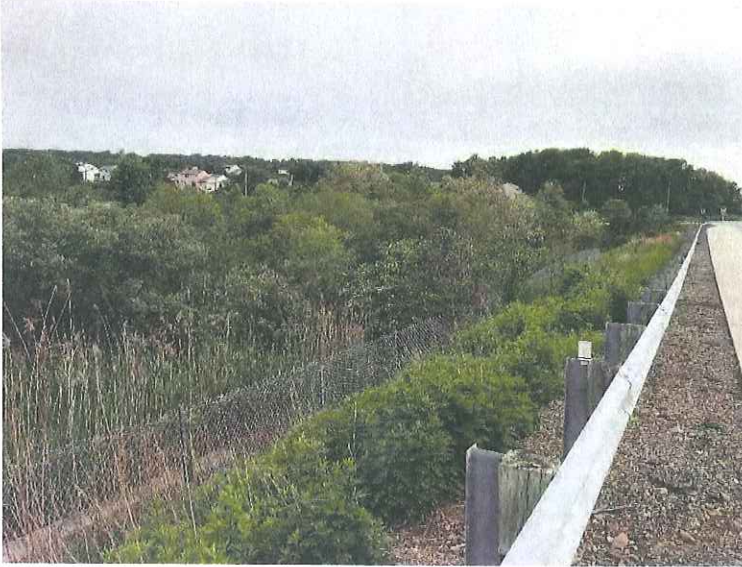
PennDOT Lancaster 6 (RE\_04)

This basin has a volunteer wetland with established wooded wetland taxa, and could be further leveraged for greater water quality treatment benefits. Adding an outlet structure – perhaps as simple as a weir wall – will retain additional water in the basin and provide greater sediment removal. The basin receives flow at the downstream end from the Kuser Dam (EC\_01), and the outlet culvert leads to PennDOT Lancaster 5 (RE\_03).

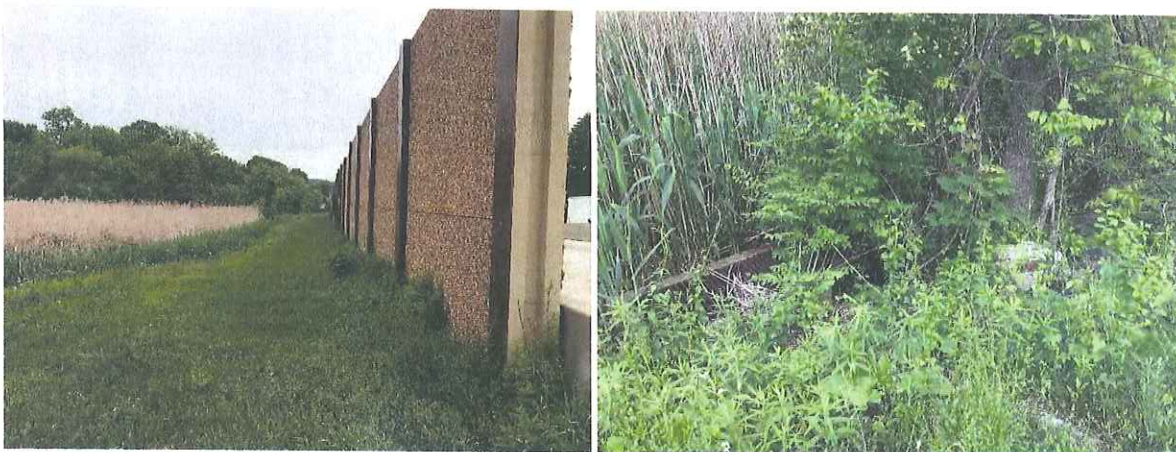
## PennDOT Lancaster 7 (EC\_02)

A wetland that was not part of the original BMP design appears to have developed in this basin adjacent to the highway barrier wall (opposite side of wall from roadway). The outlet structure is 48" from outlet invert to overflow grate. The water level in the wetland is currently 18" above the outlet invert, at the invert of the trapezoidal orifice (30" from overflow). This is most likely due to a buried and submerged low-flow orifice. The trapezoidal staged-flow orifice is not completely blocked, and the overflow is clear. It appears to receive flow from the outlet of PennDOT Lancaster 8 (EC\_03). This unintentional wetland is providing water quality treatment and there are no recommendations for maintenance or retrofit.

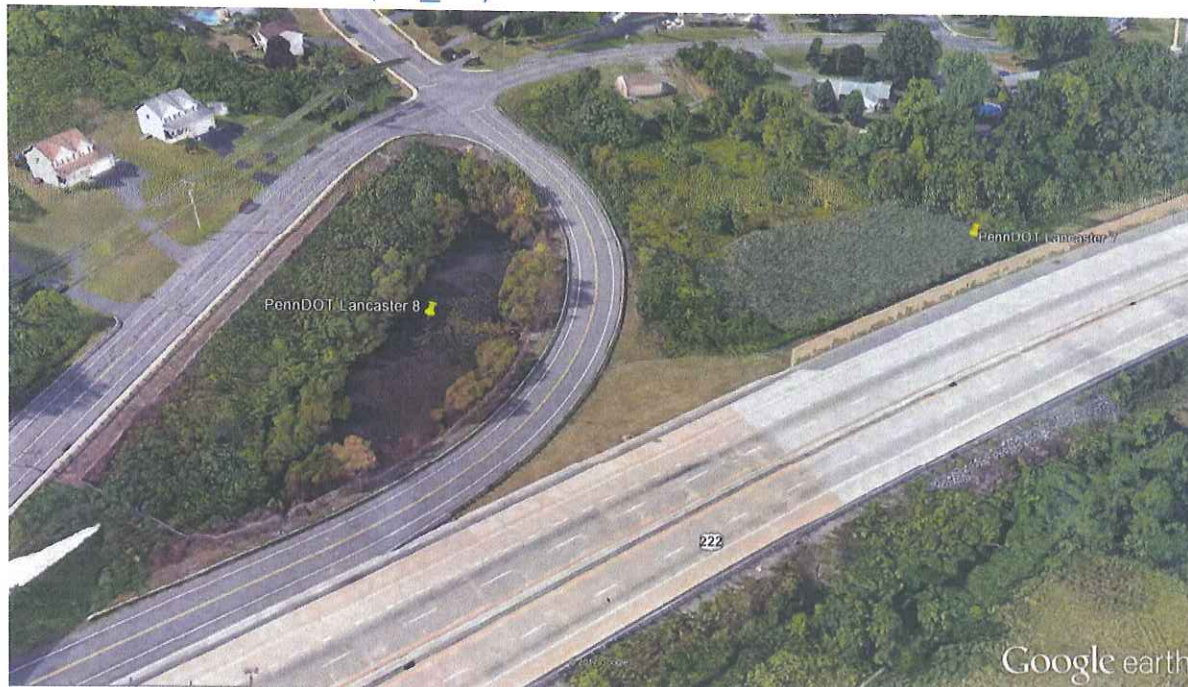
## PennDOT Lancaster 8 (EC\_03)

This wet pond estimated to have been constructed in 2003-2004 looks to still be in good condition. Wet ponds provide water quality benefit through sediment settling, and biologic processes that remove nutrient loads. The outlet appears to lead to PennDOT Lancaster 7 (EC\_02).

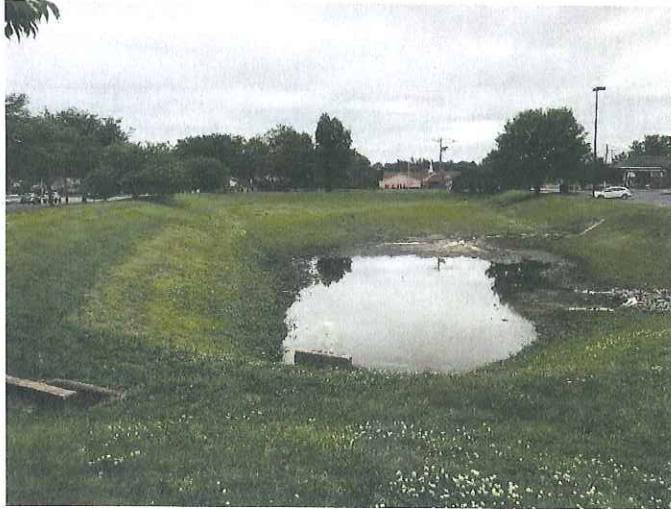
## Berkshire Boulevard – Walmart Basin (RP\_01)

The National Land Cover Dataset (NLCD) impervious cover layer used to calculate impervious cover within the drainage area was at a 30-meter resolution. In some cases, such as for this site, the low-resolution data resulted in inaccurate impervious cover percentages used to calculate load reductions per the Chesapeake Bay Retrofit Curves. Note that the impervious cover percentage of this drainage area is believed to be at least slightly higher than is reflected by the numbers above, which would in turn affect the performance efficiency of the BMP.

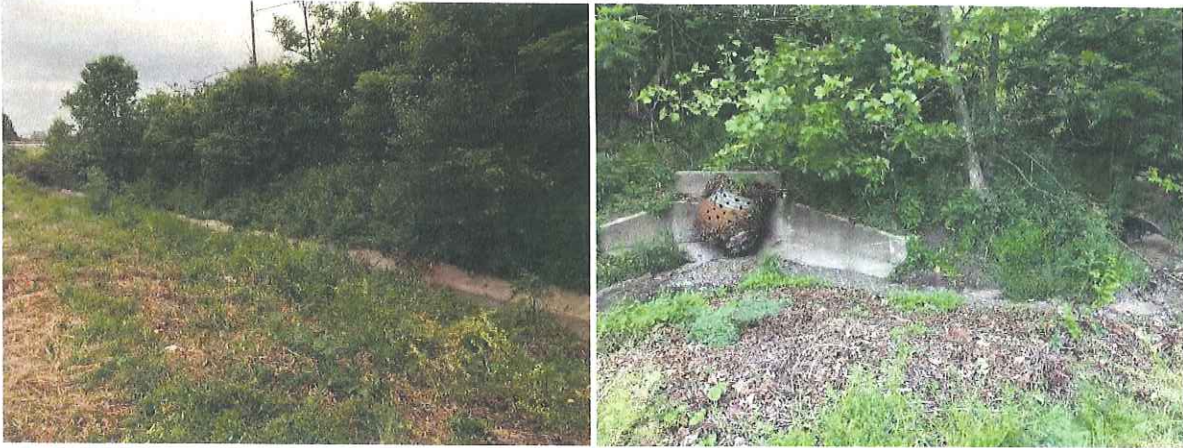
## PennDOT Ramp DB Basin (RP\_18)

This basin, like PennDOT Ramp DC Basin (RP\_19), was designed to provide some quantity control in extreme storm events. There is a concrete or stone-lined channel around the edge of the basin allowing runoff from the inlets to completely bypass the basin floor, which is between 6 inches and two feet higher than these channels. The basin outlet has a perforated metal plate to attenuate flow in some larger storm events, but this structure appears to be broken.

Recommendations are to remove the channels from inlets to outlet, excavate within the basin floor, spoil excavated soil on site in compacted and vegetated mounds, or berms to force long flow paths from the inlets. Lowering the basin floor to, or below, the inlet inverts will allow for detention and some infiltration of smaller storms and reduce runoff. The drainage areas for these basins are very large, and the potential sediment removal benefit quite high for a simple on-site earth-moving project. A more robust outlet structure to detain the 1- to 2-year storm for 24 hours, but allow high-rate flows to pass, would offer significant cost effectiveness in retrofitting. This may involve simply rebuilding the existing, damaged outlet structure. Shallow grades within the basin, including over the berms, and simple turfgrass (highway mix) vegetation won't require additional maintenance beyond that for the existing basin, but will achieve significant water quality benefits.

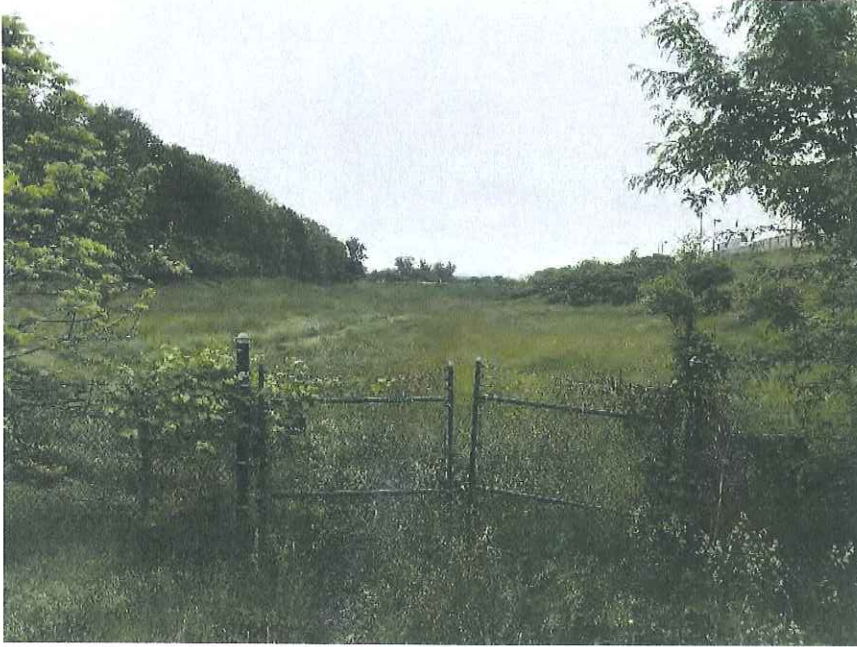
## Stanford Avenue Dam (RP\_21)

Karst topography is present in this area and any infiltration practices will need to account for safety hazards and property damage risk due to sinkholes. A thorough geotechnical analysis is recommended with multiple borings or other subterranean imaging, given the adjacency of large commercial development to the south, the dam structure at and culvert under Lancaster Pike (Route 222), and the cost associated with repairing large sinkholes. Retrofitting is only recommended provided there is little or no risk of significant sinkholes or similar issues in this basin.

- A. Change the outlet structure to at least temporarily detain small storm flows; it is our understanding that the stage-storage-discharge of this basin has room for adjustment to utilize the bottom couple feet of elevation.
- B. Create a water quality swale in the basin: remove the flume/lined channel and grade a sinuous, vegetated channel through the basin with check dams to slow runoff and allow infiltration and evapotranspiration to reduce runoff.
- C. Option A, and: Excavate within basin, use soil to form berms to retain water, allowing infiltration. The basin should be able to accommodate at least an average of one foot of ponding without any significant effect on the dam's ability to mitigate flood risks during major storm events. This is a low-cost, high-benefit option.

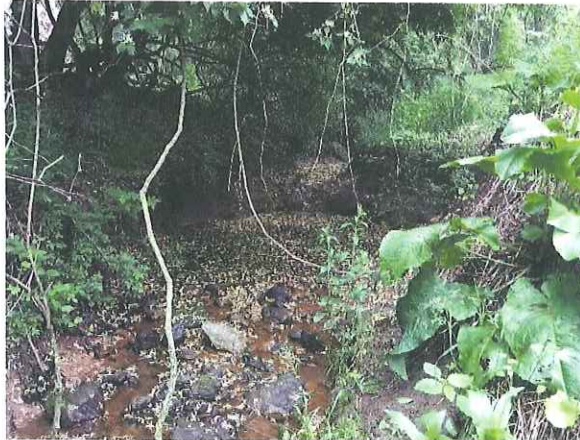
## Grove/Leininger Dam (STR\_01)

channels, eroding a significant deposit of legacy sediment. At this location, it would be beneficial to remove the accumulated legacy sediment, install in-stream grade control structures for the channels such as cross vanes and sills, and potentially merge the split channel. Bank treatments such as cribbing and muddills, and perhaps some rock or log diversions, are recommended to protect the banks from further erosion and the adjacent residential properties from incursion. It is also possible that after a natural resources survey, extending the stream restoration upstream through the wetland will also be recommended.

There is also channel erosion on the downstream sides of the dams at Grove and Leininger. These areas are not as severe as the last 200 feet before the western section of Grove, however they are degraded urban stream reaches, with impairments including pathogenic. As much as 850 feet of stream restoration could occur between Fairmont Avenue and the eastern section of Grove Avenue. At least one homeowner has a retaining wall acting as a stream diversion close to the eastern section of Grove to protect against land loss and maintain grade.

This effort should apply for Chesapeake Bay Protocol 1: Credit for Prevented Sediment during Storm Flow, at minimum.

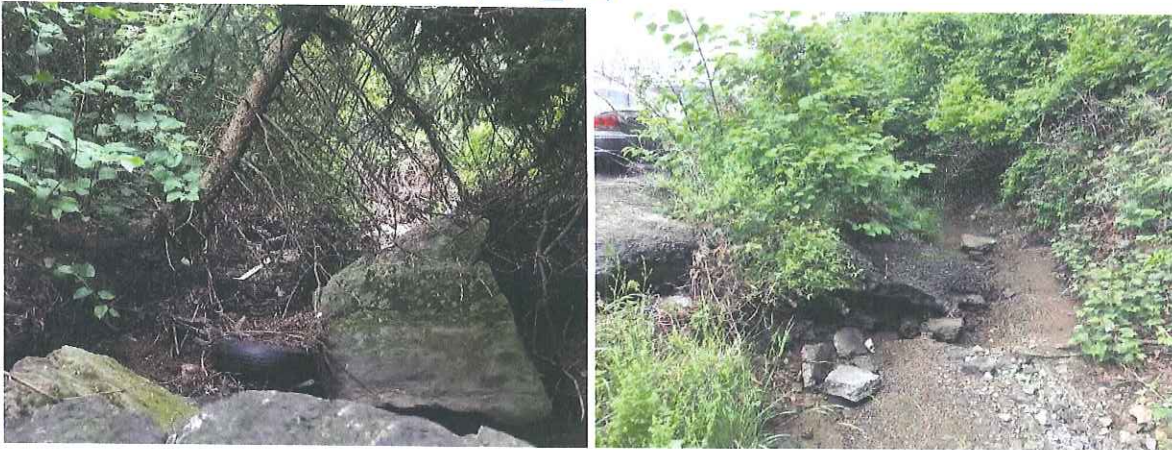
## Tom Sturgis Stream Channel (STR\_02)

The reach extending approximately 700-800 feet upstream (west) of Thomas Drive is degraded. The banks are eroding badly in places, though it appears other areas are bedrock or other hard materials, including subbase for the J.D. Byrider automobile lot. There is significant sediment deposition in the channel, and several structural obstacles to natural flow and animal movement have occurred in the channel.

We recommend applying some bank treatments such as rock vanes, live stake planting, and other fortification as necessary to protect the high stress areas. Benching may be advised to take advantage of the lower flow conditions and maintain greater flow velocities to help transport the proper amount of sediment downstream. Some structural repair of the subbase and base for the J.D. Byrider lot are necessary, though it is not clear whose responsibility that function is. It is likely that other portions of this stream – extending west past Skateway, and east of Thomas Drive – are also in need of restoration work.

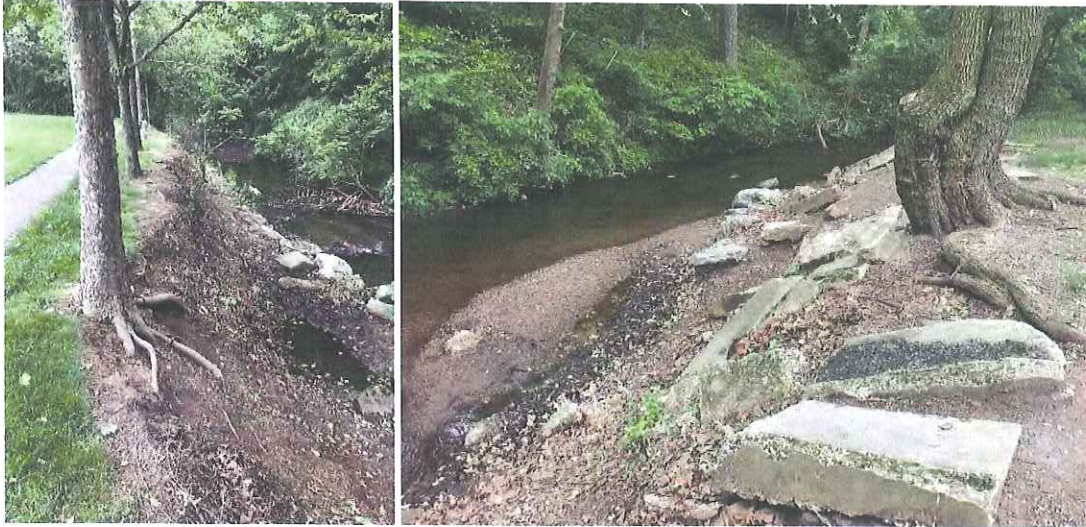
## Wyomissing Creek @ Berks County Park (Mohnton Playground) (STR\_03)

Wyomissing Creek, along Berks County Park in Mohnton and the Mohnton Playground, is experiencing some bank erosion which is threatening mature trees along the baseball fields. The inside bank, on river left, is eroding, though the bank on river right appears fairly stable throughout. There is some sediment deposition on river left which exacerbates near-bank shear stress on river right. A storm drain outfall near midway through the playground portion of the park is a corrugated metal pipe with rust in the bottom.

The outfall pipe will need to be at least lined, if not replaced, or it may soon become a safety risk. The river left banks should receive some rebuilding bank treatments such as cribbing and live stake planting, and possibly some rock structure to attenuate near-bank flow energy. As shown in the picture above, some informal attempts at bank armoring have occurred. There are some very regular stone structures in the stream channel, suggesting the possibility that some flow modification has already been implemented, though the banks are at high risk, even and in some cases especially in these areas. This is an excellent educational opportunity, and chance for exposure. This effort should apply for Chesapeake Bay Protocol 1: Credit for Prevented Sediment during Storm Flow, at minimum.

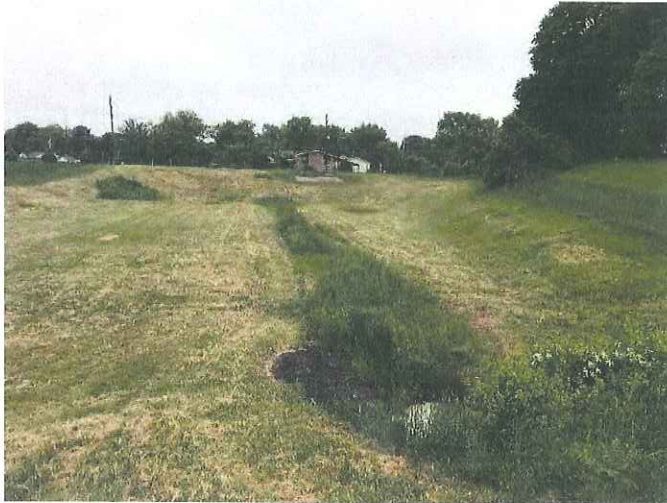
## Beverly Court Basin (RP\_02)

It appears that the overflow and high-elevation outlet are robust protection against overtopping and roadway flooding. Freeboard should not be an issue if using the bottom couple feet of elevation for water quality treatment in detention or retention.

- Excavating from the basin floor and using that soil to form berms for retention ponding areas
- Altering the low-elevation outlet by blocking the existing 30" pipe and adding either staged orifices or a perforated standpipe system to create extended detention for 24-48 hours of the design storm, and adding native vegetation for additional water quality benefit
- If stage-storage calculations verify this is a possibility, simply raising the invert of the outlet (by blocking the existing pipe) to create an infiltration basin

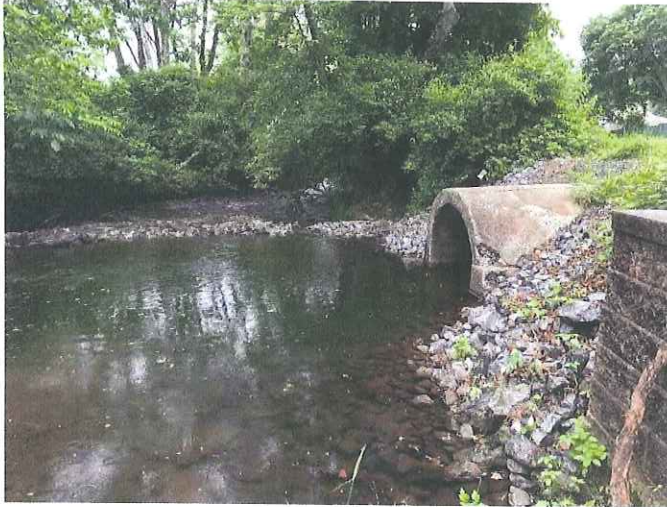
## Elm Street – Shillington (NR\_02)

After investigation and discussion, we are unfortunately unable to make any significant or confident recommendations for retrofit within the context of water quality. This is a stormwater issue that probably needs to be addressed upstream in some fashion.
